Rev 1: 22-09-2026  
FSN Ref: FSN-NL-PR-000000117-2026-01  
FSCA Ref: FSCA-NL-PR-000000117-2026-01

Date: 22-09-2026

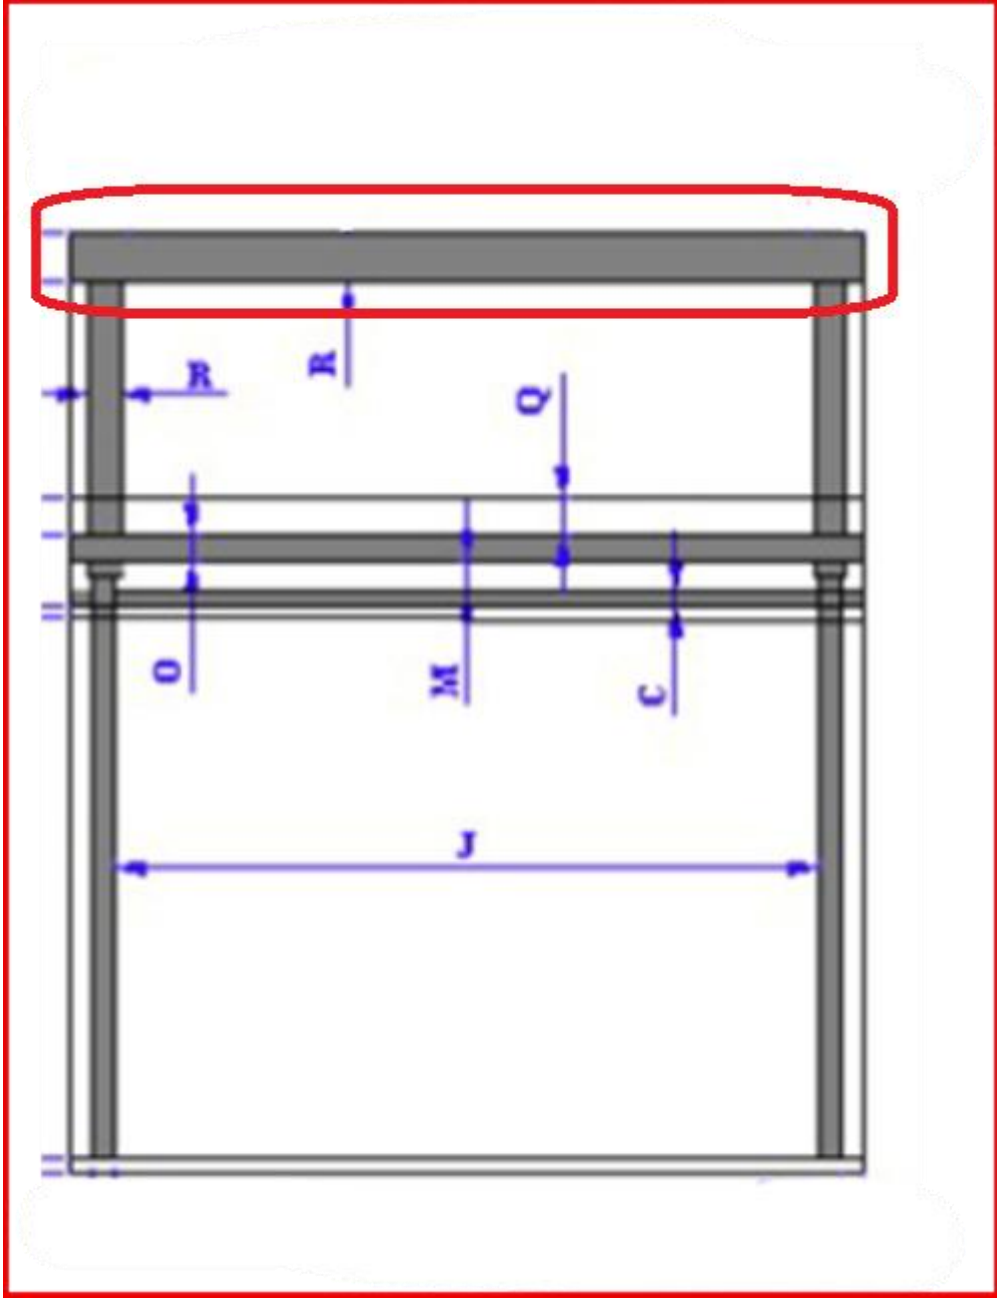
| | |
