autochair	FIELD SAFETY NOTICE	FSN Doc No.	FSN-0001
		Issue Date	27/10/17

Affected Product	SmartBase
Product Code	9934100
Manufacture Dates	February 2012 to August 2017
Serial Numbers	All
MHRA Reference	2017/008/015/601/007
Autochair Reference	AC-FSN-001-MHRA
Type of Action	Retrofit of Fail-safe Device

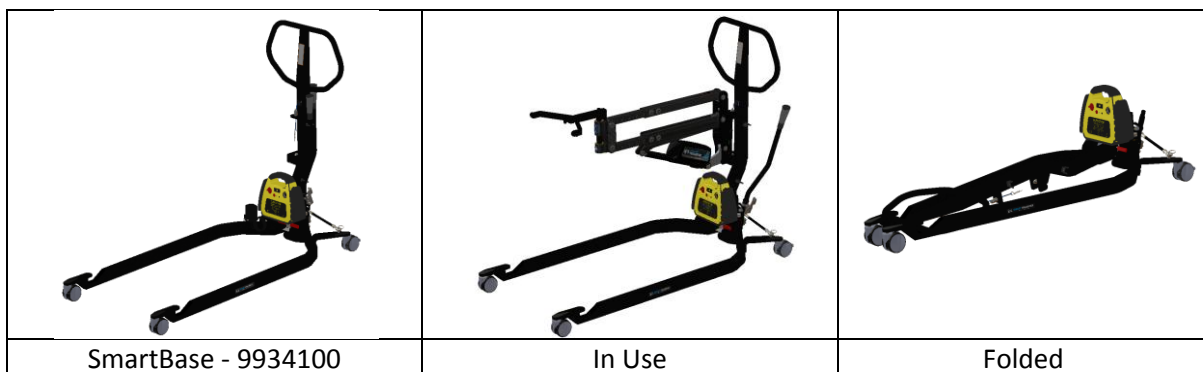
The SmartBase manufactured by Autochair Ltd is used in conjunction with the Milford Person Lift to provide a Person Lift solution. It is used to transfer users between a seat and a wheelchair and is for home use only. When not in use the device can be folded.

This FSN applies to all SmartBase units manufactured by Autochair Ltd.

The combination of a weak spring and incorrect alignment of the locking pin for latching the leg positions in the intended operating positions has led to the legs closing fully when a side load is applied to the legs. This has caused the legs to close fully to the stowed position, causing the device to become unstable and the patient to fall.

- Check the operation of the locking mechanism and, if there is any concern over the use of the device, remove it from service.
- Autochair Ltd will provide a Retrofit Fail-safe Kit which can easily be installed on all the SmartBase units.

- Upon receipt of the Retrofit Fail-safe Kit, follow the instructions provided to complete the install on the SmartBase.
- Check the Kit is fitted and operating correctly by following the checking procedure detailed in the instructions.
