No. 020	Target audience Affected users	Date 2020-09-17	Number of pages 7
Affected products Defibrillator/pacer corpuls3SLIM	Serial numbers / Lot identification from 19850001 to 20850130	Software / Firmware

with this letter we would like to inform you about the safety measures for the defibrillator/pacer corpuls3 SLIM in the serial number range from 19850001 to 20850130. This safety information concerns a limited number of devices corpuls3.

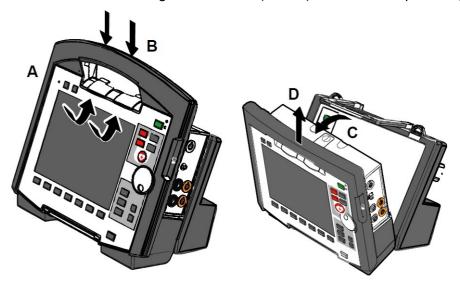
Figure 3 Disconnecting the monitoring unit from the defibrillator/pacer (illustration may differ)

Disconnecting the Monitoring Unit from the Defibrillator/Pacer:

- 1. Grasp the monitoring unit by the carrying handle and pull both snap locks simultaneously forwards and upwards with your thumbs (item A) or push them rearwards and downwards (item B).
- 2. Tilt the monitoring unit forwards (item C) and remove upwards (item D).

In case of connection problems in compact mode (please refer to Figure 4 – reference number 1) or semi-modular mode (please refer to Figure 4 – reference number 2 and 3), disconnect the device as described in Figure 3. This establishes a stable radio connection between the units. Please note that establishing the connection may take around 10s. The connection status indicates a working radio connection by a solid (non-blinking) wave symbol.

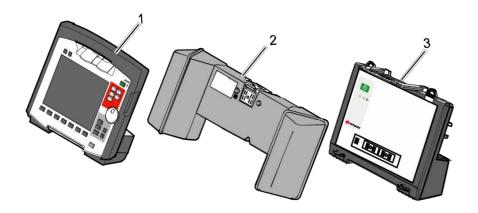
- Illustration of the device combination corpuls 3 with defibrillator SLIM
- 1 Monitoring unit
- 2 Patient box
- 3 Defibrillator SLIM
