Subject: URGENT - FIELD SAFETY NOTICE – Integra – Codman® CereLink® ICP Monitor, Model: 826820: ICP Monitor Reading Default – Field Safety Notice

826820 - Codman® CereLink® ICP Monitor
All serial numbers ranging from CLK2111003 to CLK2215542

1. Field Safety Notice (FSN) information	
FSN Reference number*	FSN-2022-HHE-006
FSN Date*	22/06/2022
Product/ Device name*	Codman® CereLink® ICP Monitor
Product Code(s)	826820
Batch/Serial Number (s)	All serial numbers from CLK2111003 to CLK2215542

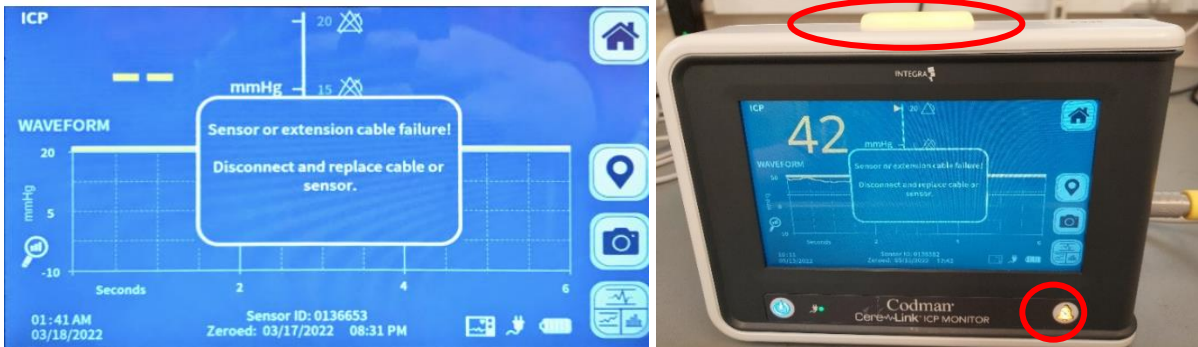
- Per standard clinical practice, patients are consistently monitored at the patient bedside, making it more likely that an abnormal ICP would be detected using clinical exam and other vital signs.
- Audible and visual alarms on the CereLink® ICP Monitor are triggered in the event of an out-of-range reading to inform the user that the failure mode is occurring (see Figures 1 and 2).

Figures 1 (left) and 2 (right): Visual alarms including display and flashing light alarm

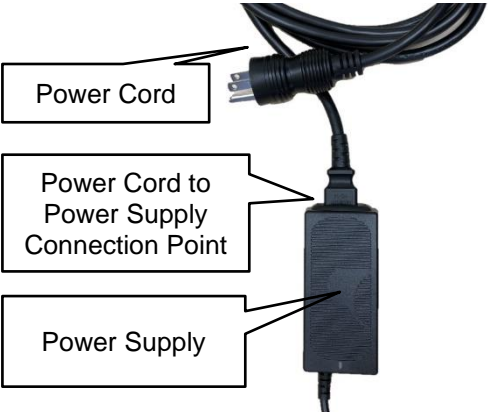
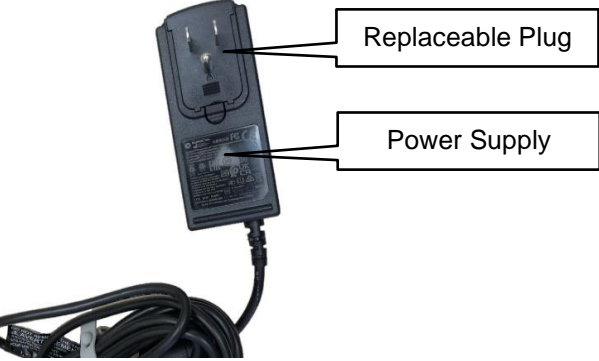
5.	<p>The CereLink® Power Supply comes with the CereLink® Monitor. The connection between the CereLink Power Supply and the outlet could come in two configurations: 1) a power cord or 2) a replaceable plug. Please ensure both are properly attached (see below).</p> <div style="display: flex; justify-content: space-around;"> <div data-bbox="268 1527 758 1989"> <p style="text-align: center;">Power Cord Configuration</p>

<p>Power Cord</p> <p>Power Cord to Power Supply Connection Point</p> <p>Power Supply</p> </div> <div data-bbox="790 1527 1391 1960"> <p style="text-align: center;">Replaceable Plug Configuration</p>

<p>Replaceable Plug</p> <p>Power Supply</p> </div> </div>
