| <b><i>Urgent Field Safety Notice – CARDIOROOT Woven grafts</i></b> | |
| <b>Manufacturer SRN:</b> | <i>FR-MF-000002878</i> |
| <b>Manufacturer's Reference Number:</b> | <i>RC045 – 1574541</i> |

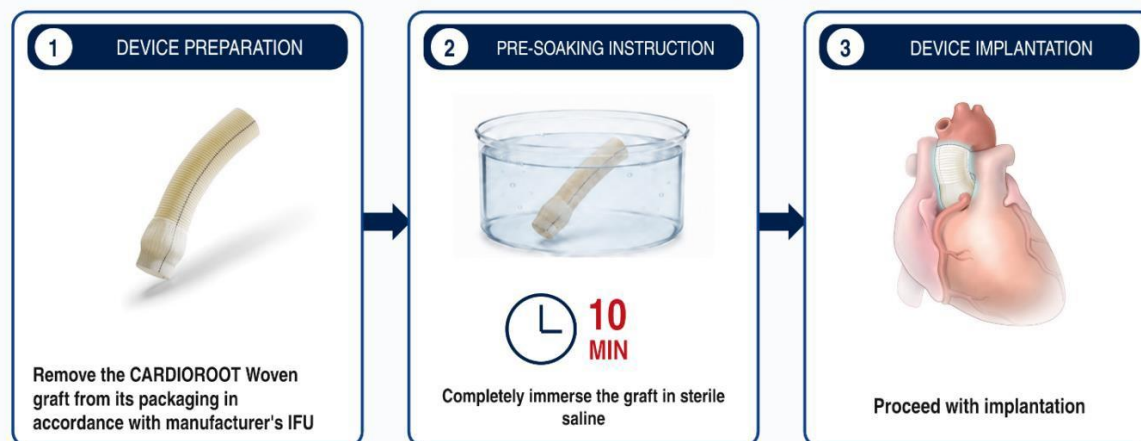
### PRE-SOAK CARDIOROOT WOVEN BEFORE IMPLANTATION

- **Pre-soaking instruction:** After removing the graft from its packaging, the CARDIOROOT Woven graft shall be immersed in sterile saline solution at room temperature (15-25°C) for **10 minutes** before implantation. The prosthesis should not be allowed to dry out prior to implantation. Once implanted, confirm hemostasis of the CARDIOROOT device.

Immerse completely in sterile saline at room temperature (15–25°C) for 10 minutes

**Exception:** Internal testing demonstrated that conducting a 10-minute saline pre-soak restored the IWP value to within the specified acceptance criteria in all tested CARDIOROOT Woven samples. Given this fact, if no suitable alternative device is available at the facility, and postponing surgery is not clinically appropriate, the operating physician must follow the following instructions:

- Failure to pre-soak the graft for 10 minutes may increase the potential for perioperative bleeding through the affected graft wall during implantation.
