Date: 17/04/2025

Urgent Field Safety Notice

VARIOUS BVM RESUSCITATORS

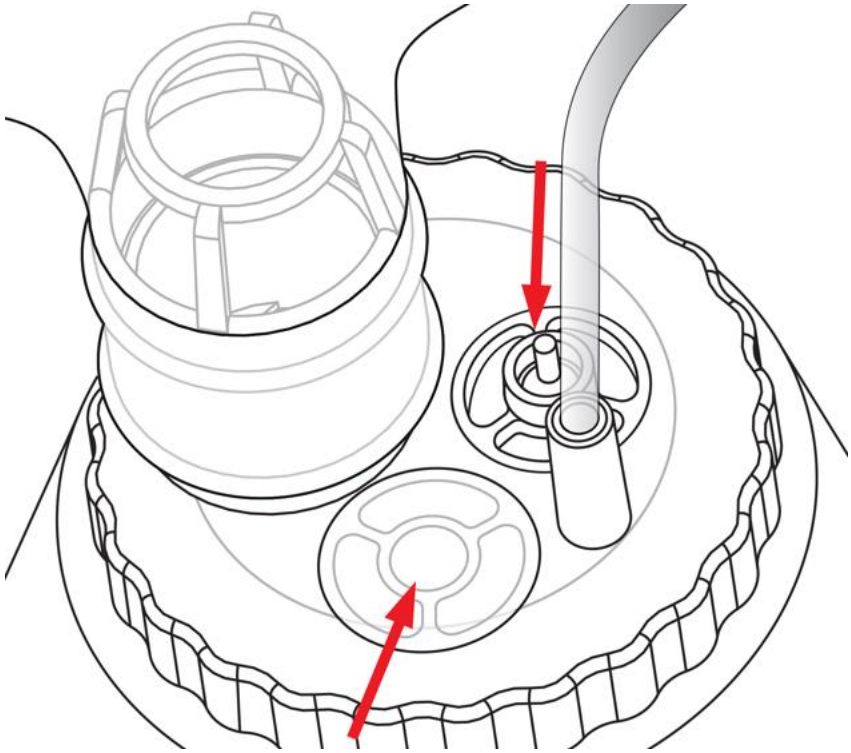
Some devices have been identified during pre-use checks as missing one of the valves at the rear of the BVM Resuscitator, position as shown below.

If the BVM has been supplied without the one valve that controls entrainment of atmospheric air, which would result in dilution of Oxygen concentration and reduction of delivered FiO2. This does not have an impact upon the ability to provide adequate ventilation but does have an impact upon the ability to deliver the higher Oxygen concentrations as detailed in the product instructions for use. This may result in negative impact upon clinical outcome during CPR.

2.	5. Further information to help characterise the problem
	N/A
2.	6. Background on Issue
	Following a customer report from the market and subsequent thorough inspection and analysis of internal stock, we have identified that some products have been manufactured without one of the valves at the rear of the BVM Resuscitator.

2.	7. Other information relevant to FSCA N/A
	3. Type of Action to mitigate the risk*
3.	**1. Action To Be Taken by the User*** ☒ Identify Device ☒ Quarantine Device ☐ Return Device ☐ Destroy Device ☐ On-site device modification/inspection ☐ Follow patient management recommendations ☒ Take note of amendment/reinforcement of Instructions For Use (IFU) ☒ Other ☐ None Please distribute this Field Safety Notice to all potential users of the BVM Resuscitators listed above, within your facility. This is for their awareness of the potential problem and to carry out the following actions. To ensure the safety of patients we recommend the following actions. 1. Identify any potentially affected products from the affected codes and lot numbers listed above. 2. All users must perform a thorough visual inspection before use of the products and lot numbers listed above, to confirm both one-way valves are present.

3.	**5. Action Being Taken by the Manufacturer** ☐ Product Removal ☐ On-site device modification/inspection ☐ Software upgrade ☐ IFU or labelling change ☒ Other ☐ None Corrective actions have been implemented in the manufacturing process to eliminate this problem for future supply.	
3	6. By when should the action be completed?	As soon as possible from receipt of the FSN
