# **URGENT Field Safety Notice**

SmartPerfusion, release Rl.O, Rl.1, Rl.1.1, Rl.1.5, Rl.1.5.1 and Rl.1.6
20 Perfusion, release Rl.O.x, Rl.1.x, Rl.2 and Rl.2.1
Used with Philips Allura Xper and Azurion Systems

#### SmartPerfusion and 2d Perfusion May Inaccurately Present Time Density Curves and Images

20-February-2023

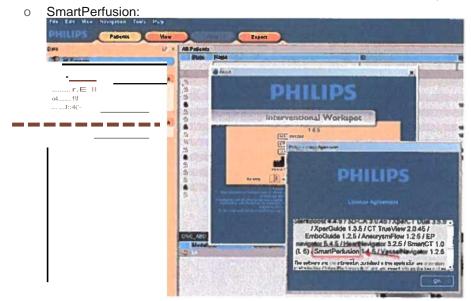
Pic 3: Check if SmartPerfusion or 2D Perfusion license is available on the system (see red box and arrow)
