Identification of potentially affected sample probes for cobas c501/ cobas c502 and cobas c311

Identification of potentially affected sample probes for cobas c701/ cobas c702

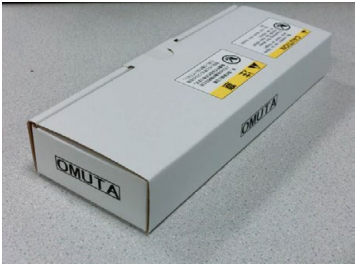
04547241001 PROBE SAMPLE (cobas c501/ cobas c502)	
05899427001 PROBE SAMPLE S (cobas c311)	
Affected serial number which printed on the probe	<p>NAKA; 1509-001 onward, and <u>no marked yellow dot</u> on the connector. OMUTA; 1535-001 onward, and <u>no marked yellow dot</u> on the connector.</p> <p>Refer to Place of yellow dot on the connector in this table for detail.</p>
Identification of production site in HHT	<div style="display: flex; justify-content: space-around;">

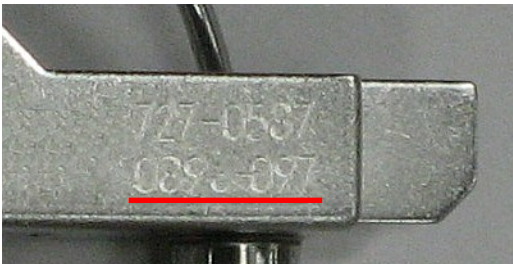
</div> <p>Either NAKA or OMUTA is indicated on the original package. Either Black or Green dot is marked on the sample probe.</p> <p>Black dot: Produced by NAKA Green dot: Produced by OMUTA</p>
Printed place on sample probe	<div style="display: flex; justify-content: space-around;">

</div> <p>Refer to Rule of printed serial number for detail.</p>

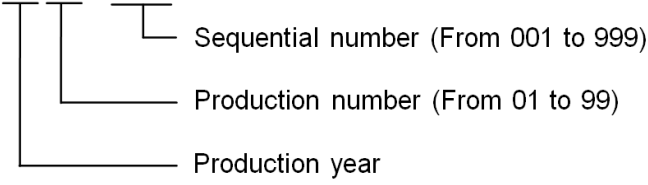
<p>Rule of printed serial number</p>	<p>727-0587 ← Part number YY AA – BBB ← Serial number</p>

<p>Sequential number (From 001 to 999) Production number (From 01 to 99) Production year</p> <p>Serial number printed on the probes for cobas c501/c502 and cobas c311 are making a common numbering by HHT's two production lines.</p>
<p>Place of yellow dot on the connector</p>

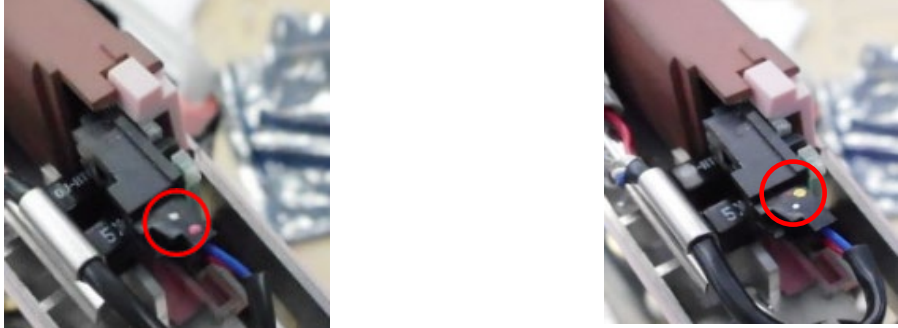
<p><u>No yellow dot mark</u> on the connector is affected. If the yellow mark on the connector is existed, the probe was modified done by HHT despite if the Serial number which printed on the probe was met.</p>
<p>SAP lot number which printed on the original package</p>

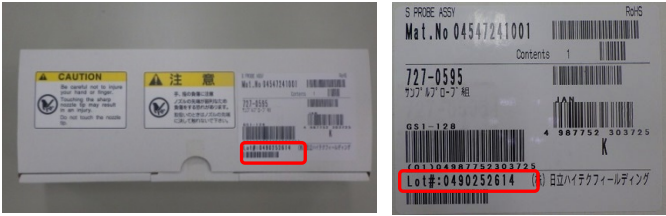
<p>Affected Sample Probe for cobas c311 (P/N 724-0920)</p>	<p>Lot number which indicated on the logistics label 0490232027, 0490233855, 0490236427, 0490238543, 0490241937, 0490248322, 0490250880, 0490235713, 0490252029, 0490256963</p>
<p>Affected Sample Probe for cobas c 501 and c502 (P/N 727-0595)</p>	<p>0490233762, 0490233764, 0490233766, 0490233767, 0490233777, 0490235904, 0490235905, 0490235906, 0490235907, 0490235949, 0490235950, 0490237594, 0490237595, 0490237353, 0490237354, 0490237597, 0490237598, 0490237600, 0490237602, 0490237604, 0490237606, 0490238955, 0490238957, 0490238893, 0490238895, 0490238896, 0490238898, 0490238899, 0490242149, 0490242151, 0490242153, 0490242155, 0490242327, 0490242328, 0490242329, 0490242330, 0490242331, 0490250491, 0490250492, 0490250493, 0490250494, 0490250495, 0490250496, 0490251032, 0490251033, 0490251034, 0490251036, 0490252524, 0490252527, 0490252529, 0490252532, 0490252247, 0490252249, 0490252251, 0490252252, 0490252272, 0490252398, 0490254550, 0490254551, 0490254552, 0490254553, 0490254554, 0490254555, 0490254804, 0490254805, 0490254806, 0490254807, 0490256999, 0490257000, 0490256993, 0490256994, 0490256995, 0490256996, 0490256997, 0490256998, 0490254808, 0490257001, 0490257847, 0490257848, 0490257849, 0490257850, 0490257851, 0490258652</p>

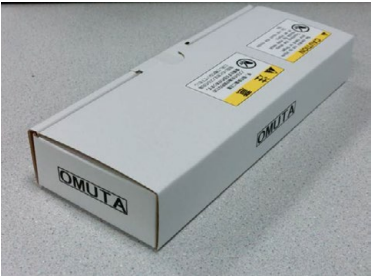
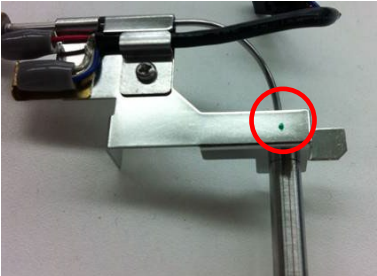
04945794001 SAMPLE PROBE (cobas c701/ cobas c702)	
Affected serial number which printed on the probe	ISE and Sample Probe for cobas c701/ cobas c702 do not have serial number printed on the probe itself.
Identification of production site in HHT

<p>Either NAKA or OMUTA is indicated on the original package. Either Black or Green dot is marked on the sample probe.</p> <p>Black dot : Produced by NAKA Green dot : Produced by OMUTA</p>
Place of yellow dot on the connector

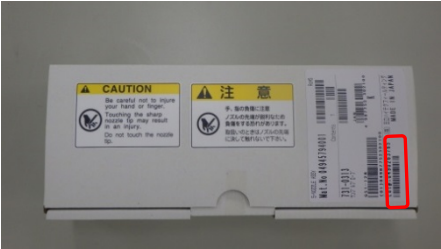
<p><u>No yellow dot mark on the connector is affected.</u> If the yellow mark on the connector is existed, the Sample Probe was already modified by HHT.</p>
SAP lot number which printed on the original package

<p>Refer to the separate attachment for detail of SAP lot numbers which printed on the original package.</p>

Affected Sample Probe for cobas c701/ cobas c702 (P/N 731-0313)	0490238960, 0490238961, 0490238961, 0490238961, 0490238963, 0490242332, 0490251040, 0490251041, 0490252546, 0490252547, 0490252547, 0490254810, 0490254811, 0490221658, 0490223228, 0490223229, 0490225255, 0490226172, 0490226173, 0490226174, 0490227626, 0490227627, 0490227628, 0490230276, 0490230277, 0490230279, 0490232203, 0490232204, 0490232205, 0490232206, 0490233778, 0490233779, 0490233780, 0490233781, 0490233783, 0490235909, 0490235910, 0490235911, 0490235912, 0490235913, 0490237365, 0490237366, 0490237367, 0490237368, 0490237369, 0490237370, 0490238901, 0490238902, 0490238903, 0490238904, 0490242160, 0490242161, 0490242163, 0490242165, 0490242166, 0490250498, 0490250499, 0490250500, 0490250501, 0490250502, 0490252308, 0490252312, 0490252318, 0490252320, 0490252322, 0490254558, 0490254559, 0490254560, 0490254561, 0490254562, 0490257035, 0490257036, 0490257037, 0490257038, 0490257039, 0490257854, 0490257855, 0490257856, 0490257857, 0490257858
