URGENT FIELD SAFETY NOTICE

Product Name: **Alaris™ GS, GH, CC, TIVA, PK, Enteral Syringe Pump**

Product Name: **Asena™ GS, GH, CC, TIVA, PK Syringe Pumps**

FSCA Identifier: **RA-2017-02-02**

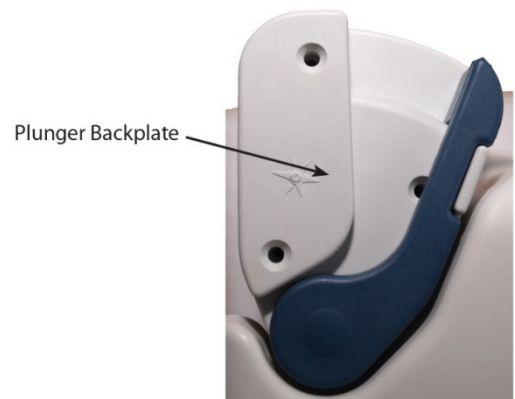
Appendix 4 – Plunger Backplate Spring Replacement

1. Remove three screws holding plunger backplate.
2. Remove the plunger backplate.
Note: Be cautious when removing as parts may become loose. Placing the Pump in a vertical orientation may assist with maintaining components in place.
3. Visually inspect the interior of the plunger, replace any broken components.
See Technical Service Manual *Chapter 6 Corrective Maintenance* for further details.

Recommended during every Preventative Maintenance and at the minimum every three years that the plunger backplate spring is replaced.

A kit of 10 replacement springs is available, part number 1000SP01589.

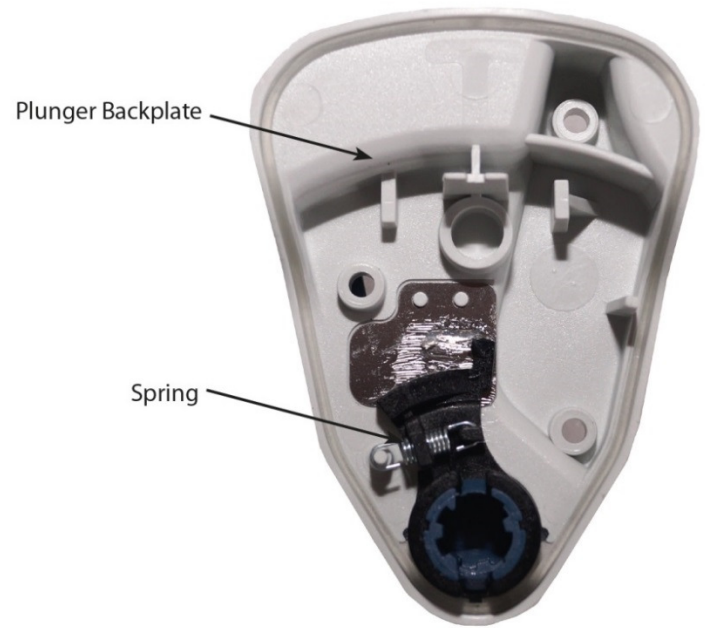
4. Remove the spring from the plunger backplate.
5. Fit a new spring to the plunger backplate.
6. Refit the plunger backplate.
7. Fit the three screws into the plunger backplate.
