Urgent Field Safety Notice

BVM (Bag-Valve-Mask) Manual Resuscitation Systems

Manufacturer: Intersurgical Ltd

FSCA-identifier: 170124

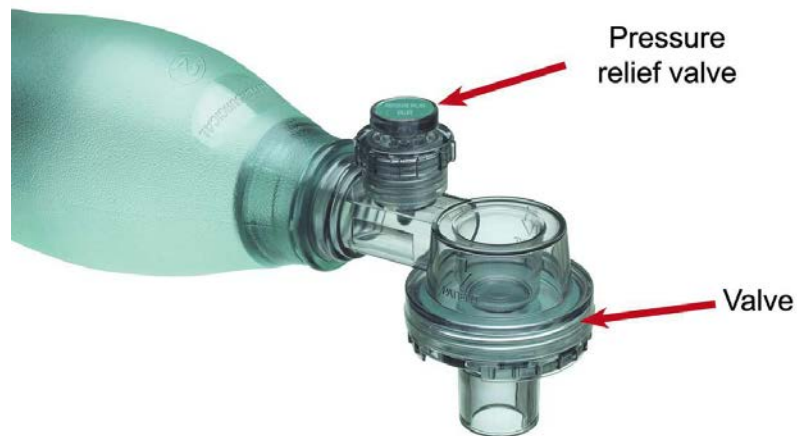
Description of the problem: There is a possibility the valve of the BVM Manual Resuscitation System may become stuck during storage. This could result in the intended tidal volume not being delivered through the valve, which may cause a delay in treatment.

Picture 1: Position of valve and pressure relief valve if included in the system

1. Ensure the valve opens prior to use when squeezing the resuscitation bag (Picture 1).
2. If the valve is stuck (Picture 2), squeeze the bag fast and firmly to open the valve (Picture 3).
3. If the BVM Manual Resuscitation System contains a pressure relief valve (Picture 1) manually hold this closed to prevent it from opening when squeezing the bag. Repeat action 2 whilst the pressure relief valve function is overridden.
4. Make sure the valve is now open and fully functional prior to use.

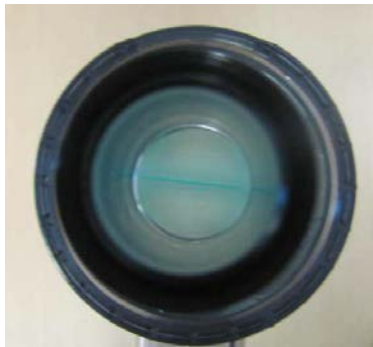
Picture 2: Stuck valve

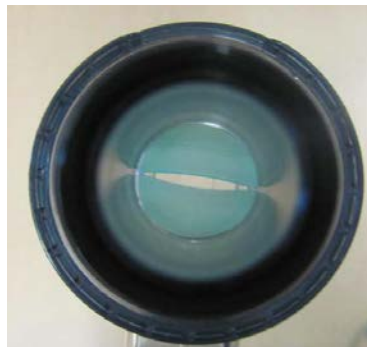
Picture 3: Open valve
