Date:	22 nd June 2020
Product Name and Number:	4230-00 Neurosign V4 Intraoperative Nerve Monitor: 4444-00 Neurosign V4 Pre-Amplifier (affected components) 4440-00 Neurosign V4 Stimulator Pod (affected components)
FCA Reference Number:	FCA-2020-02
Type of Action:	Preventive Action
At the attention of:	Distributor / Owner / User

URGENT FIELD SAFETY NOTICE
Medical Device Recall

Ref.: FCA-2020-02

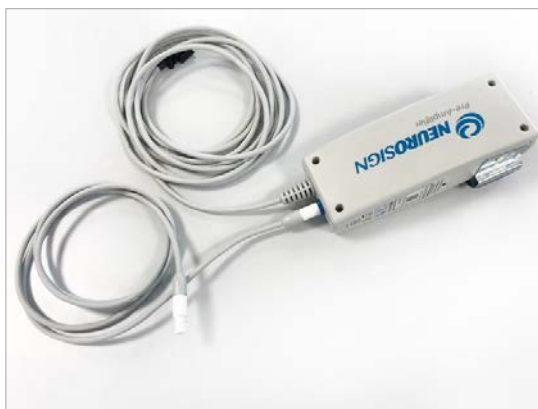
The products affected belong to the Neurosign V4 Intraoperative Nerve monitor family of devices. The Neurosign V4 Intraoperative Nerve Monitor serial numbers affected are S/N: 0001 – 0049, specifically the Pre-amplifier and Stimulator Pod cables for these systems.

Figure 1: The Neurosign V4 Pre-amplifier and Stimulator Pod Cable

Magstim are issuing a voluntary corrective action following reports that manipulation of the cable which connects the pre-amplifier to the nerve monitor, and the cable which connects the pre-amplifier to the stimulator pod, may cause damage to the internal construction of the cables. This may result in:

- Failure of the stimulator pod to be recognised by the system, in which case the user will be given a visual and audible warning;
- Or a partial failure of the pre-amplifier cable affecting the audible EMG audio; however, this does not affect the EMG waveform visible on the screen.

- Identify all affected products at your facility
- Raise awareness to all users of the device(s) within your organisation
- If you have forwarded any affected product to other organisations, please forward them a copy of this notice, and advise us accordingly on the acknowledgement form
- Complete and return the attached acknowledgement form, so we can contact you to arrange replacement of the cable.

- Users should continue to routinely inspect all devices for damage or signs of wear before use, as described in the operating manual.
- If damage is found or your device is exhibiting the failure modes described, contact the service department to arrange a repair or replacement.
- If damage is not found and the device is behaving as expected, the device can continue to be used whilst a replacement is arranged. Care should be taken to properly store the Pre-Amplifier and Stimulator Pod using the cable storage aids provided.

The affected cables have been re-designed to improve the longevity and cable performance. Using the details provided on the acknowledgement form, we will arrange for a replacement of affected cables at your facility to the updated design. It is important to return the acknowledgement form as soon as possible so that we can arrange for your cables to be replaced. In the meantime, you can continue to use your device(s).
