Manufacturer's Ref Number: CT-20-00324

**Urgent Field Safety Notice**  
**Niobe ES**

**Urgent Field Safety Notice (FSN)**  
**Niobe ES**  
**Potential Fire Hazard**

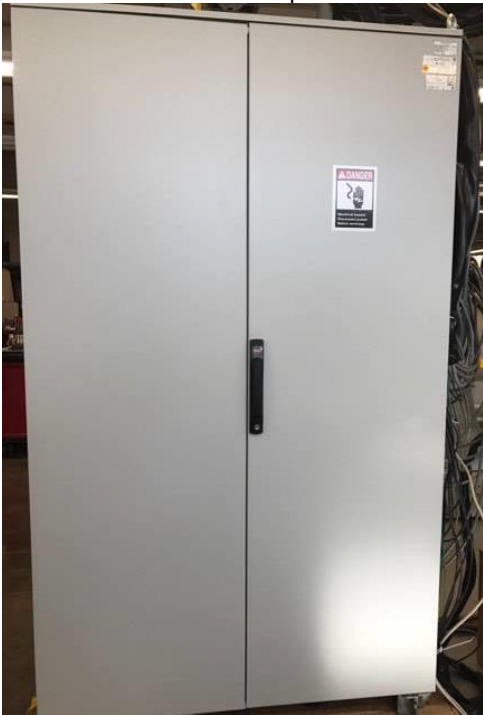
<b>3. Type of Action to mitigate the risk*</b>	
<b>3.</b>	<p><b>1. Action To Be Taken by the User*</b></p> <p> <input checked="" type="checkbox"/> Identify Device               <input type="checkbox"/> Quarantine Device               <input type="checkbox"/> Return Device               <input type="checkbox"/> Destroy Device         </p> <p> <input type="checkbox"/> On-site device modification/inspection         </p> <p> <input type="checkbox"/> Follow patient management recommendations         </p> <p> <input type="checkbox"/> Take note of amendment/reinforcement of Instructions For Use (IFU)         </p> <p> <input type="checkbox"/> Other                      <input type="checkbox"/> None         </p> <p>Please respond to this FSN with the Serial Number of the MCC and UIC in the Niobe computer cabinet. Please follow these steps in order to identify the Serial Numbers. Please contact Stereotaxis personnel if assistance is required.</p> <p>1. Locate the Niobe Computer Cabinet</p>

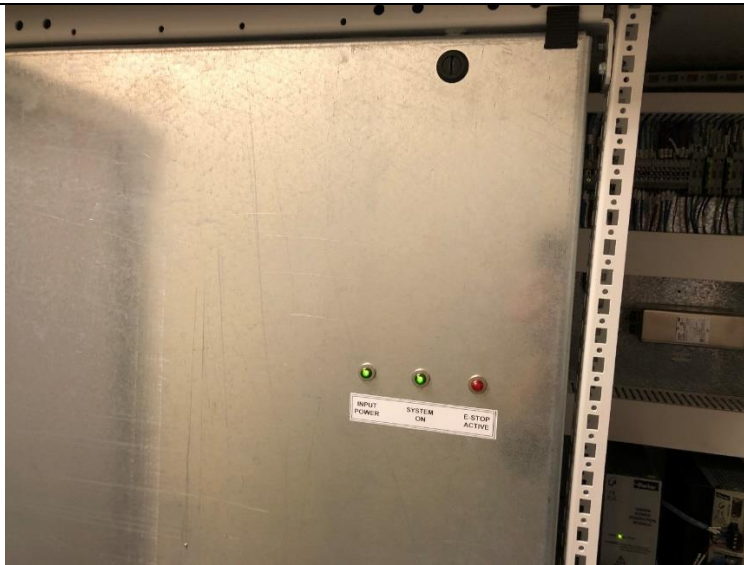
<p>2. Open Niobe Computer Cabinet</p> <p>3. Locate the Swing Door inside of the Niobe Computer Cabinet</p>

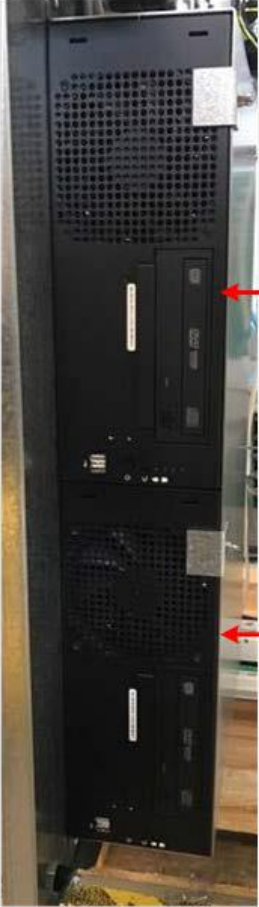
5. Record UIC and MCC Serial Numbers on FSN Customer Response Form

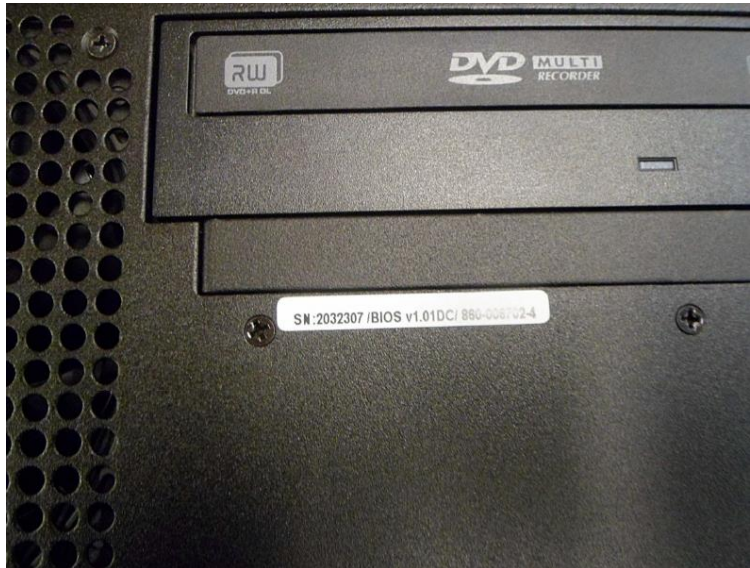
3.	2. By when should the action be completed?	6. Return completed FSN Customer Response Form to Stereotaxis personnel Within 30 days of receipt
