FSN Ref: FSN_Elefant_20200903

FSCA Ref: FSCA_Elefant_20200903

Date: 2020/09/14.

Urgent Field Safety Notice
ELEFANT® SUCTION/IRRIGATION DEVICE
for Specific lots

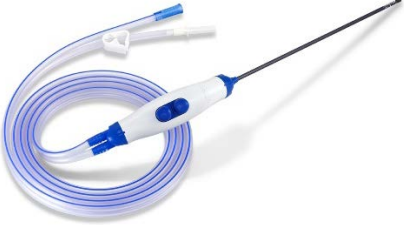
1. Information on Affected Devices*																
1	<p>1. Device Type(s)*</p> <p>Elefant® is a single use disposable suction-irrigation device and can be used whenever laparoscopic procedures are performed. The cannula is inserted through a trocar and the device is connected on a suction system and irrigation bag(s).</p> <p>The device is composed mainly of:</p> <ul style="list-style-type: none"> - 1 connecting tube - 1 handling grip - 1 cannula with eyes on the distal end
