Urgent Field Safety Notice**Field safety corrective action****concerning
OCT-Camera 211 01 A1 and 211 01 A3**

01.10.2020

HAAG-STREIT SURGICAL GmbH & Co. KG
Rosengarten 10
22880 Wedel

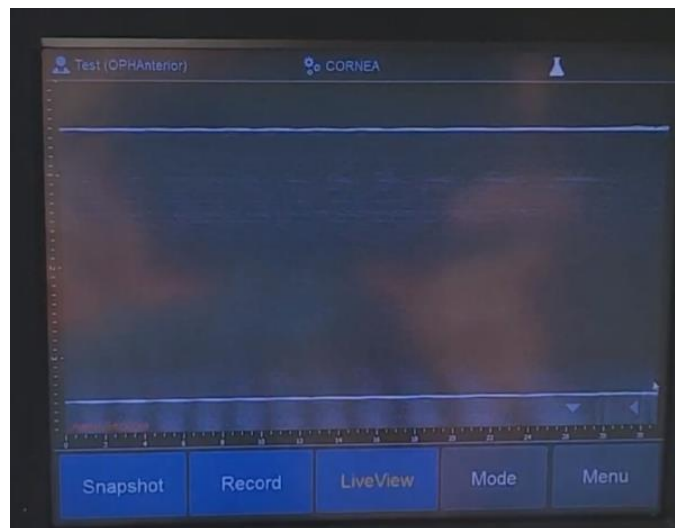
If the movement of the mirror fails due to a technical error, the laser diode is automatically switched off and no damage to the eye can occur. If this automatic deactivation fails to function in the event of a second error, the stationary laser beam could cause permanent damage to the retina of the patient's eye.

The OCT camera is equipped with an automatic laser beam shut-off to protect the patient's eye. As a result of a malfunction, the OCT unit might not recognize whether the laser beam is safely switched off as described.

Should one or more continuous straight lines be displayed on the screen of the OCT camera during an operation on the posterior segment of the patient's eye (see picture), the described risk possibly exists.

OCT image in case of error

1. switch off the OCT camera immediately (menu OCT -> Switch off).

The OCT camera is not permitted to be used any more. Please contact your responsible country representative.

2. Perform the software update of the OCT camera. You will receive the new software version via your local representative, who will correct the error.
3. Please fill out and return the enclosed response form as soon as the software update has been performed.
