Subject: **URGENT MEDICAL DEVICE FIELD SAFETY NOTICE (REMOVAL)**

Affected Product: Vanguard® Knee System, Posterior Stabilized Open Box Femoral

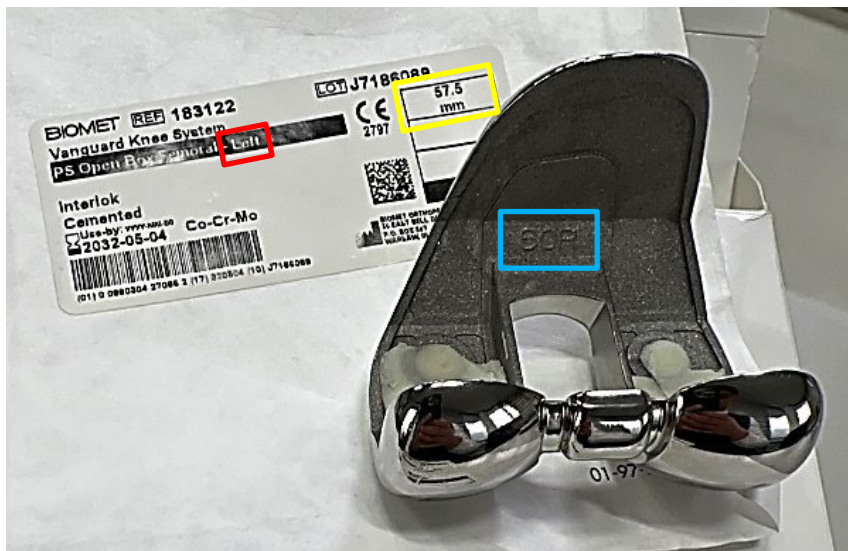
Picture on the left

Label Item Number: 183122
 Label Lot Number: J7186089
 Label Size: 57,5 mm (in yellow box)
 Label Side: Left (in red box)

Actual Size: 60 mm
 Actual Side: Right
 On item identifiable as: "60R" (in blue box)

Biomet Orthopedics LLC is conducting a medical device Field Safety Corrective Action (removal) for two lots of Vanguard Posterior Stabilized Open Box Femoral components due to a commingle. Two complaints were received with no patient impact for packaging that was incorrectly labeled as either smaller or larger and as the incorrect side (right/left). Please see above example. The incorrectly labeled products could have the potential risks as described in the table below.

1. Review this Field Safety Notice and ensure that affected personnel are aware of the contents.
2. If you have affected product at your facility, assist your Zimmer Biomet sales representative and quarantine all affected product. Your Zimmer Biomet sales representative will remove the affected product from your facility.
