## URGENT Field Safety Notification

Tempus Pro Monitor  
Unexpected Device Error When Used With Tempus Pro Video Laryngoscope

15-AUG-2023

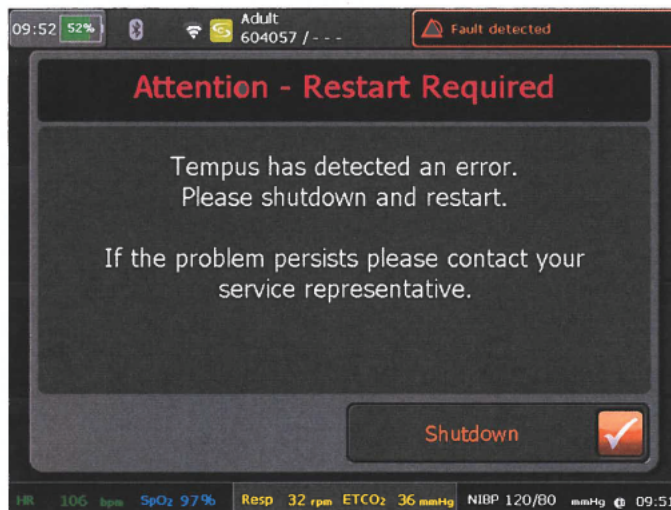
An issue has been identified with the Tempus Pro Monitor where an error may occur during video laryngoscope use with the Tempus Pro Video Laryngoscope or immediately after the Tempus Pro Video Laryngoscope has been unplugged from the Tempus Pro Monitor. If this error occurs, the user is presented with an unexpected full screen message informing the user an error has occurred, requiring shutdown and restart of the Tempus Pro Monitor. This full screen message prevents the user from viewing any graphical representation of patient vital signs; however, text and numerical values are still visible on the device's display screen. A visual of the message is shown below:

If this error occurs, the pulse tone (audio) that reflects the patient's level of oxygen saturation is no longer sounded. Additionally, the user will no longer be able to visualize the airway requiring the user to either intubate the patient without video imaging or use an alternative laryngoscope not connected to the Tempus Pro Monitor. This message cannot be cleared from the Tempus Pro Monitor's screen, and

most of the monitoring functions are not available, until the user initiates a complete shut down and restart of the device, which may take 60-100 seconds.

- If the Tempus Pro Monitor has **Trizeps-7** Hardware, remove the Tempus Pro Video Laryngoscope from service with this monitor. Users must use an alternative laryngoscope not connected to the Tempus Pro Monitor to manage the patient's airway to avoid interruption in patient care. The Tempus Pro Monitor can remain in service if the Tempus Pro Video Laryngoscope is not connected to the monitor.
- If the Tempus Pro Monitor has **Trizeps-6** Hardware, the Tempus Pro Video Laryngoscope can continue to be used with the monitor.
- Post this Urgent Field Safety Notification letter on or near your Tempus Pro device.
- Complete and return the Urgent Field Safety Notification response form included, no later than 30 days from receipt.

Philips has developed a software update to resolve this issue that is expected to be available in Q3 2023. When it is available, Philips will provide the updated software and installation instructions (via a downloadable link) for customer installation. Upon customer request, Philips can also provide a USB

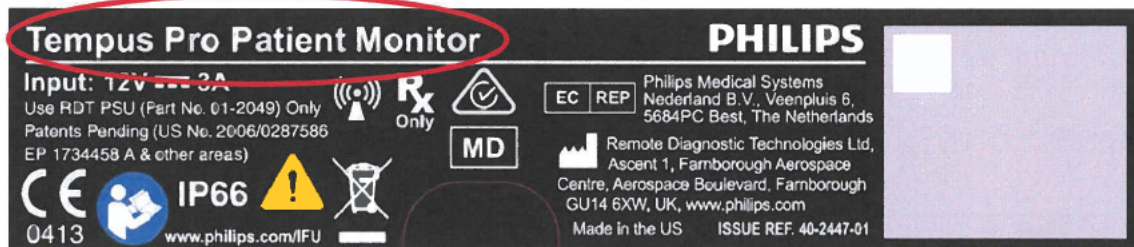
This correction affects Tempus Pro Monitors with Part Numbers 00-1004-R, 00-1007-R, 00-1024-R, and 00-1026-R with Trizeps-7 hardware, while using the Tempus Pro Video Laryngoscope with Part Number 01-2044. Tempus Pro Monitors are identified by a label placed on the rear of the device. An example is shown below:

The product number (REF) and Serial Number (SN) are printed in the gray box.
