URGENT FIELD SAFETY NOTICE

ASTOPAD

FSN Ref. #2023-11_en

FSCA Ref. #2024-01_en

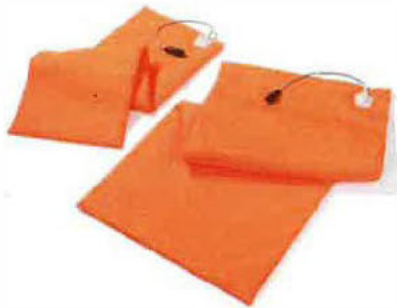
COV applied parts (blanket)

SOF and COV applied parts manufactured from May 2022 to October 2023 may potentially have internal (not visible from outside) damaged electrical insulation at a few distinct locations. The root cause is an error in the manufacturing process of the heating element. The damage could lead to localized overheating. This was identified during internal investigation after a single reported adverse event in which a patient received a burn approx. 3 cm in diameter.

The manufacturer will provide an adapter for all affected applied parts. To supplement the existing circuit protection in the control unit, the adapter contains an additional fuse that opens when the electrical contact conditions described above are met. Instructions to connect the adapter to the affected applied parts will be included. Once properly connected per the instructions, the adapter must not be removed.
