Urgent Field Safety Notice

New warning in Instructions for Use for Ambu® aView™ 2 Advance

Ambu A/S - Single Registration (SRN): DK-MF-000001437

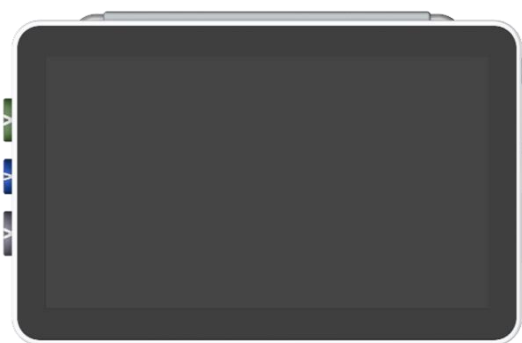
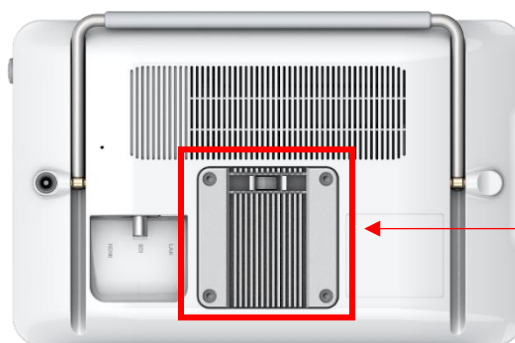
VESA interface for mounting on medical carts

Use only M4 screws with the length of 14 – 16 mm when mounting Ambu aView 2 Advance on a VESA interface. Using longer screw lengths will penetrate the lithium-ion battery and result in a fire hazard and battery leakage which can cause severe burns, smoke inhalation and skin irritation. Using shorter screw lengths could result in unsecure device fastening.
