Urgent Field Safety Notice

VARIOUS MAPLESON F ANAESTHETIC BREATHING SYSTEMS CONTAINING 0.5L RESERVOIR BAGS WITH OPEN TAILS

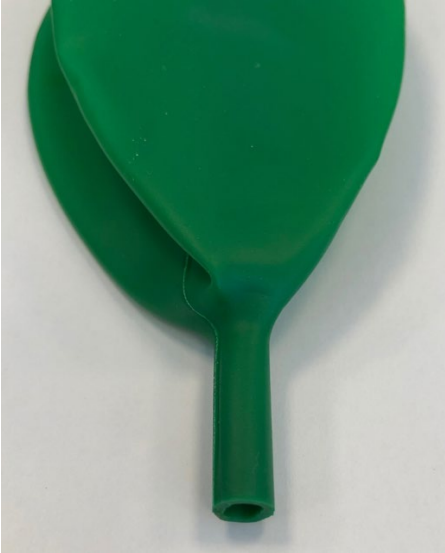
| | <p>Some devices contain a reservoir bag with a closed tail, when they should have a reservoir bag with open tail.</p> <div style="display: flex; justify-content: space-around; align-items: center;"> <div style="text-align: center;"> <p>Correct – Open Tail Reservoir Bag</p> </div> <div style="text-align: center;"> <p>Incorrect – Closed Tail Reservoir Bag</p> </div> </div> |

| 2. | <p>2. Hazard giving rise to the FSCA*</p> <p>If the incorrect closed tail reservoir bag is not identified during the routine pre use check as described in the product instruction for use, it could result in over pressurisation of the system leading to potential barotrauma.</p> |

| | <p>We have implemented corrective actions in manufacturing process to eliminate this problem for future supply. We will also be introducing a new instruction for use which will include the following Pre-Use Check in line with the recommended action 2. above:</p> <p><i>If the product is supplied without an APL valve, the pressure within the system is controlled by the clinician through manipulation of the open tail on the reservoir bag. Check that a patent gas pathway exists through the open tail of the reservoir bag.</i></p> | |

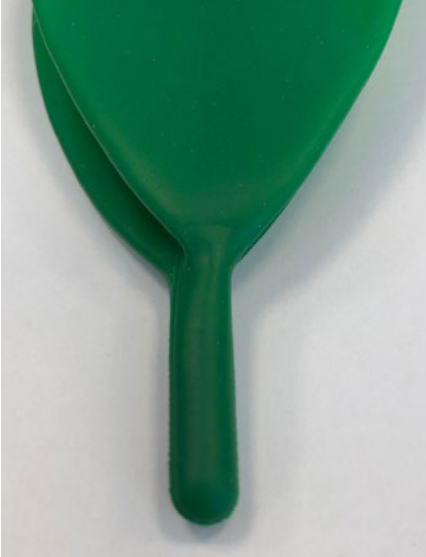
| 2. | <p>6. Background on Issue</p> <p>Following a customer report from the market and subsequent thorough inspection and analysis of internal stock, we have identified a potential safety concern related to various Mapleson F paediatric anaesthetic breathing systems as listed above. Unfortunately some products have been manufactured with a 0.5 L reservoir bag with a closed tail which could result in over pressurisation of the system.</p> |

| <p>3.</p> | <p>1. Action To Be Taken by the User*</p> <p> <input checked="" type="checkbox"/> Identify Device <input type="checkbox"/> Quarantine Device <input type="checkbox"/> Return Device <input type="checkbox"/> Destroy Device <input type="checkbox"/> On-site device modification/inspection <input type="checkbox"/> Follow patient management recommendations <input checked="" type="checkbox"/> Take note of amendment/reinforcement of Instructions For Use (IFU) <input checked="" type="checkbox"/> Other <input type="checkbox"/> None </p> <p>Please distribute this Field Safety Notice to all potential users of the Mapleson F paediatric anaesthetic breathing systems listed above, within your facility. This is for their awareness of the potential problem and to carry out the following actions.</p> <p>To ensure the safety of patients we recommend the following actions.</p> <p>1. Identify any potentially affected products from the affected codes and lot numbers listed above.</p> <p>2. All users must perform a thorough visual inspection and functional test before use of the products and lot numbers listed above, to confirm a patent gas pathway exists through the open tail of the reservoir bag to avoid over pressurisation of the system.</p> <p>3. Retain any affected sample(s) identified, and please report to us immediately.</p> <p>Please note: This is not a product removal.</p> <p>Please complete and return the Reply Form provided to giedriusb@intersurgical.lt (local contact e-mail address), to confirm receipt of this notice and that the necessary actions are being taken-</p> <p>Please continue to report to Intersurgical any adverse events involving this product.</p> | |
