## **URGENT Field Safety Notification**

Tempus Pro Monitor  
Unexpected Device Error When Used With Tempus Pro Video Laryngoscope

06-NOV-2023

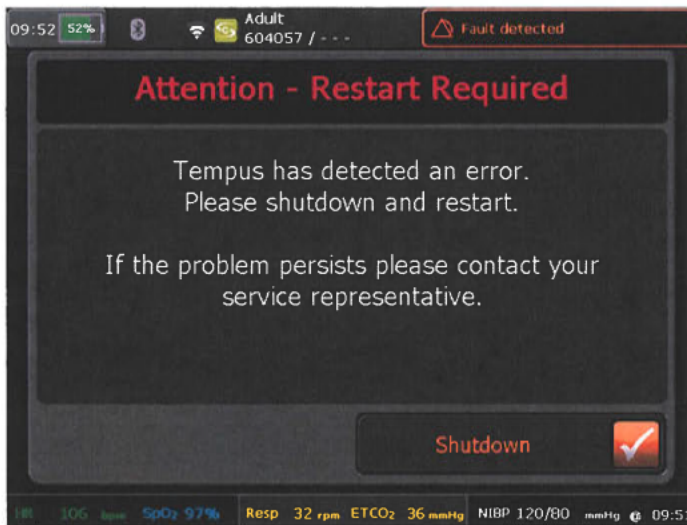
An issue has been identified with the Tempus Pro Monitor where an error may occur during video laryngoscope use with the Tempus Pro Video Laryngoscope or immediately after the Tempus Pro Video Laryngoscope has been unplugged from the Tempus Pro Monitor. If this error occurs, the user is presented with an unexpected full screen message informing the user an error has occurred, requiring shutdown and restart of the Tempus Pro Monitor. This full screen message prevents the user from viewing any graphical representation of patient vital signs; however, text and numerical values are still visible on the device's display screen. A visual of the message is shown below:

If this error occurs, the patient pulse tone (audio) that reflects the patient's level of oxygen saturation is no longer sounded and there will be no additional patient or device alarm LEDs or audio alarms while the error message is displayed. Additionally, the user will no longer be able to visualize the airway requiring the user to either intubate the patient without video imaging or use an alternative

laryngoscope not connected to the Tempus Pro Monitor. This message cannot be cleared from the Tempus Pro Monitor's screen and most of the monitoring functions are not available until the user initiates a complete shut down and restart of the device, which may take 60-100 seconds.

- When you receive the updated software solution from Philips, please install the software (V07.34) on your Tempus Pro Monitor according to the installation instructions provided. Once updated, you may resume use of the Tempus Pro Video Laryngoscope if you had removed it from service.

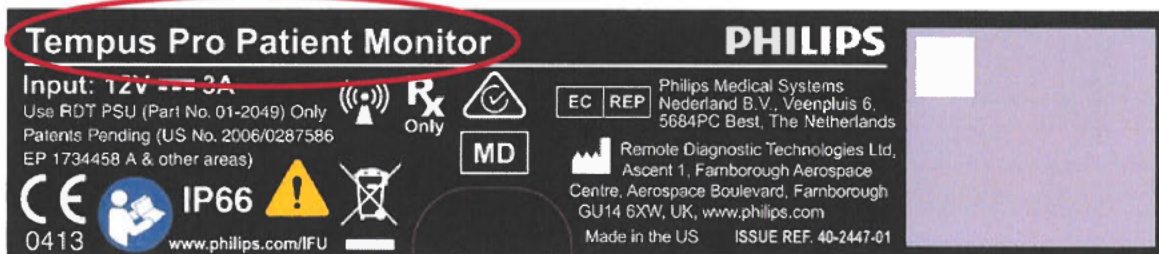
This correction directly affects Tempus Pro Monitors with Part Numbers 00-1004-R, 00-1007-R, 00-1024-R, and 00-1026-R with Trizeps-7 hardware, software v07.26 through v07.30, while using the Tempus Pro Video Laryngoscope with Part Number 01-2044. While Tempus Pro Monitors with Part Numbers 00-1004 and 00-1007 are not directly affected, these devices may have their hardware updated to Trizeps-7 hardware so are being included in this correction as a precaution. Tempus Pro Monitors are identified by a label placed on the rear of the device. An example is shown below:

The product number (REF) and Serial Number (SN) are printed in the gray box.

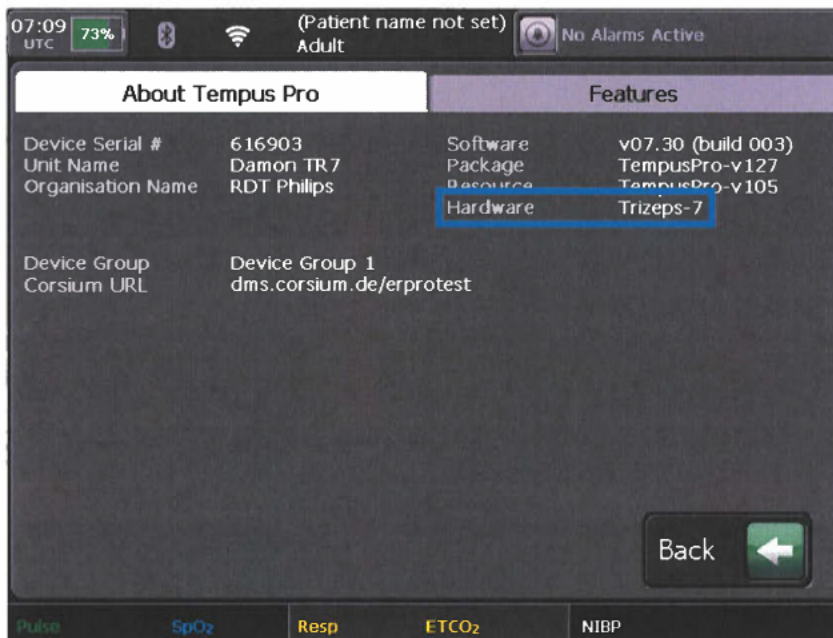
- Check the 'About Tempus Pro' screen on the Tempus Pro monitor(s) to determine which Hardware version is present by following these steps:

To access the 'About Tempus Pro' screen:

1. Press the blue 'Menu' button on the Tempus Pro monitor keypad

2. Scroll down to the last page of the menu (page 4 of 4)

3. Press 'About Tempus Pro'

4. Identify the Hardware Version (Trizeps-7 or Trizeps-6)

- If the Tempus Pro Monitor has **Trizeps-7** Hardware, remove the Tempus Pro Video Laryngoscope from service with this monitor. Users must use an alternative laryngoscope not connected to the Tempus Pro Monitor to manage the patient's airway to avoid interruption in patient care. The Tempus Pro Monitor can remain in service if the Tempus Pro Video Laryngoscope is not connected to the monitor.

- If the Tempus Pro Monitor has **Trizeps-6** Hardware, the Tempus Pro Video Laryngoscope can continue to be used with the monitor.
- Post this Urgent Field Safety Notification letter on or near your Tempus Pro device.
