Urgent Field Safety Notice (FSN)
XtremeCT

1. Information on Affected Devices									
1.	1. Device Type CT-system (HR-pQCT)

1.	2. Commercial name XtremeCT								
1.	3. Primary clinical purpose of device This computed tomography system is designed to measure the bone density and quantify the three-dimensional micro architecture of the bone at the human extremities. The equipment will be used in the diagnosis and treatment monitoring of osteoporosis.								
1.	4. Affected serial or lot number range <table border="1" style="width: 100%; border-collapse: collapse;"> <thead> <tr> <th>ScannerID</th> <th>Serial Nr</th> <th>ScannerID</th> <th>Serial Nr</th> </tr> </thead> <tbody> <tr> <td>SC3300</td> <td>04043001</td> <td>SC3326</td> <td>07110900</td> </tr> </tbody> </table>	ScannerID	Serial Nr	ScannerID	Serial Nr	SC3300	04043001	SC3326	07110900
ScannerID	Serial Nr	ScannerID	Serial Nr						
SC3300	04043001	SC3326	07110900

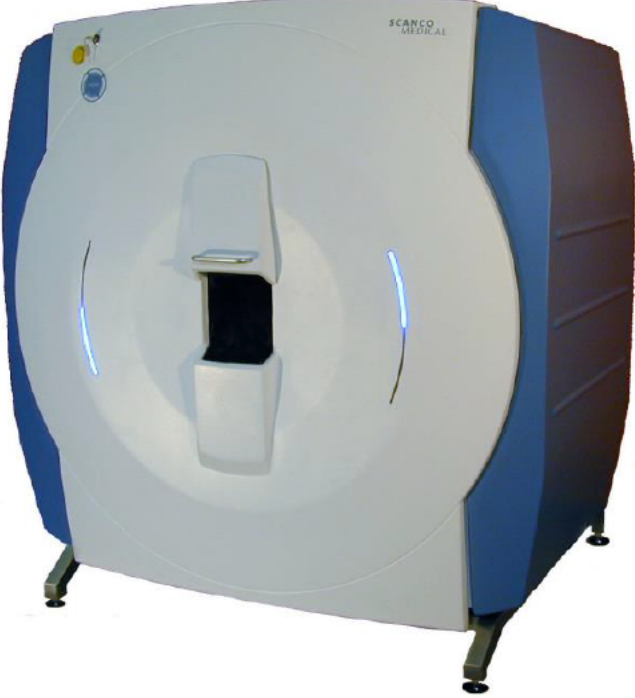
2. Reason for Field Safety Corrective Action (FSCA)	
2.	<p>1. Description of the product problem</p> <p>A vertically mounted metal plate inside the bore may fall down due to component degeneration.</p>

2.	<p>2. Hazard giving rise to the FSCA</p> <p>Patient harm is possible: The plate may fall down when a patient extremity is in the bore, potentially injuring the patient. No harm to users or third parties is possible. If the actions outlined in the FSN are followed, there is no residual risk.</p>

3. Type of Action to mitigate the risk	
3.	<p>1. Action To Be Taken by the User</p> <ul style="list-style-type: none"> <input checked="" type="checkbox"/> Identify Device <input checked="" type="checkbox"/> Quarantine Device <input type="checkbox"/> Return Device <input type="checkbox"/> Destroy Device <input type="checkbox"/> On-site device modification / inspection <input type="checkbox"/> Follow patient management recommendation <input checked="" type="checkbox"/> Take note of amendment / reinforcement of Instructions For Use (IFU) <input type="checkbox"/> Other <input type="checkbox"/> None <p>The device must not be used until the corrective action has been performed by the manufacturer.</p>

3.	4. Action Being Taken by the Manufacturer <input type="checkbox"/> Product Removal <input checked="" type="checkbox"/> On-site device modification/inspection <input type="checkbox"/> Software upgrade <input checked="" type="checkbox"/> IFU or labelling change <input type="checkbox"/> Other <input type="checkbox"/> None <p>The manufacturer SCANCO Medical AG will improve the mounting system of the metal plate. The IFU has been amended to include an updated maintenance plan. After 5 years the mounting system of the metal plate must be serviced.</p>
