URGENT FIELD SAFETY NOTICE and MEDICAL DEVICE CORRECTION

Action Reference: RA2026- 4264880

Product Description: Chromophare

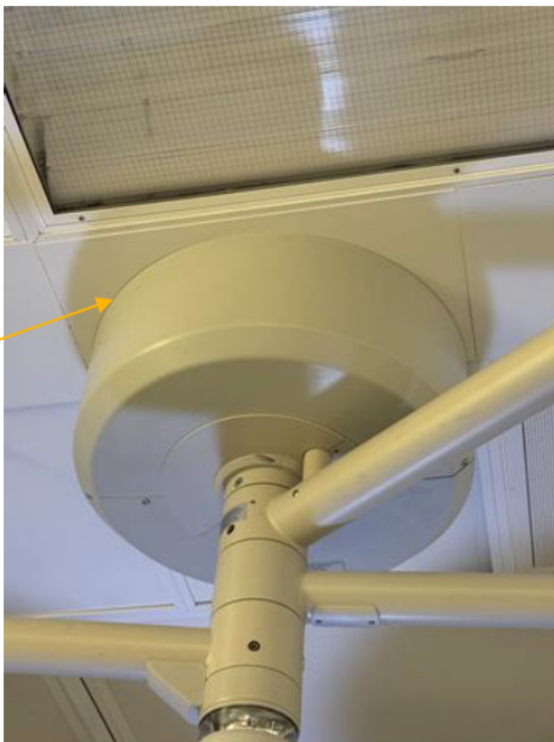
Image 2: Example of a ceiling cover that is flush to the ceiling

- a. If a gap is observed, stop use and report this to Service immediately at xxxxxxxxxxxx@stryker.com. Please see Image 3 below as an example.
- b. If no gap is observed, the product may continue to be used per the instructions for use. Please see Image 2 below as an example.

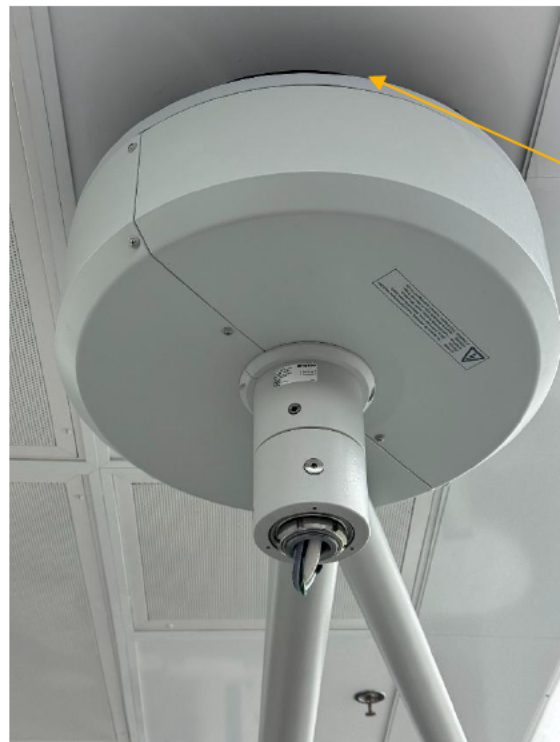
Reason for the Recall Stryker has discovered that certain lots of the soffit ring may not adequately support the weight of the ceiling cover. As a result, the cover may shift or slide down the ceiling tube. Movement of the ceiling cover can expose the area above the ceiling, which may allow particles, such as dust, debris, residue, or other contaminants, to enter the sterile field.

Image 3: Example of a ceiling cover that is not flush with the ceiling

4. A representative will contact affected accounts to schedule a field service visit to complete an inspection and replacement of the affected component.
